The rest area, which is located at a highway 2, consists of 2/3 truck parking spaces and lanes. The rest area has repeatedly been the scene of truck departures. Television sets, computers and sports equipment were stolen. The police caught only a few thieves in the act.

A video-radio system was installed to monitor the rest area:

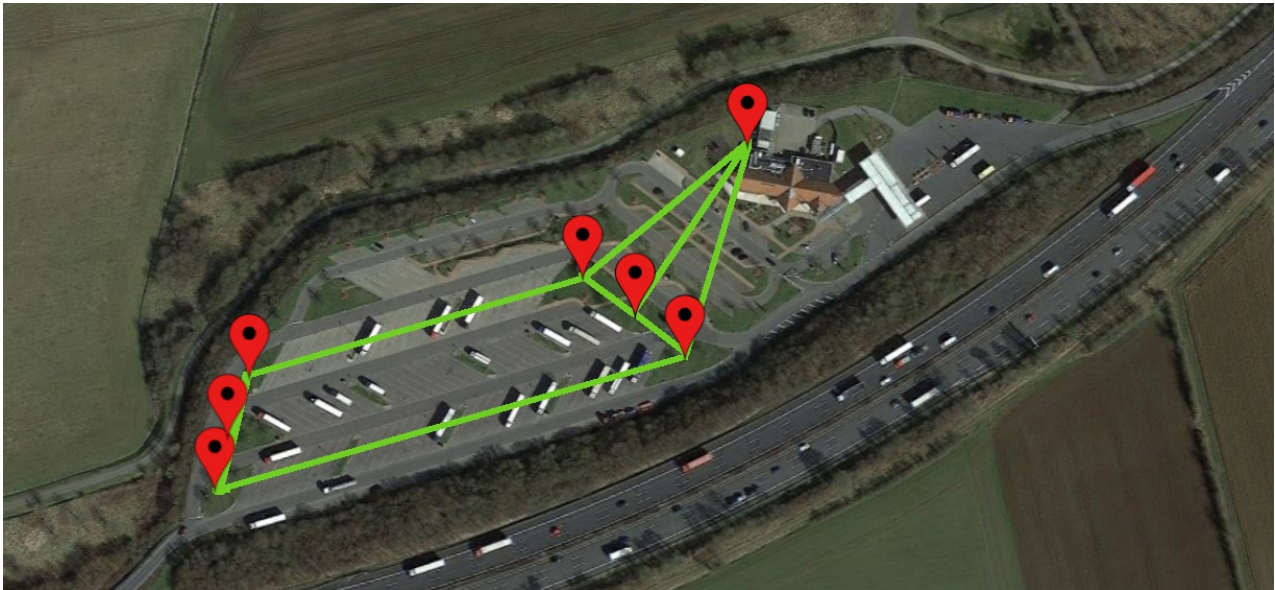
The wireless routers installed on existing light masts not only transmit the camera data, they also feed the cameras via the PoE interfaces. It is possible to install the wireless routers and cameras on existing light poles and has the advantage that the power supply of the light poles can be used for the wireless router.

Even in adverse weather conditions at night, camera images are transmitted via the wireless system. Once installed, the system operates autonomously and is not subject to any maintenance. The cameras are positioned in such a way that one mast is equipped with three cameras each, so that the lanes can be monitored from different angles.

The images from the total of 18 cameras are transmitted to a central point in the service area via the video radio system. According to the Association of German Car Repair Stations (VEDA), billions are lost every year throughout Germany to freight forwarders and insurance companies due to cargo theft. Every sixth truck driver has been a victim of cargo theft. This leads beside the loss of the commodity also to damage to property, as well as not least the endangerment and uncertainty of many professional drivers
